**Manitowoc River Watershed
Baseline Survey 2005-2006**

**By
Steve Hogler, Steve Surendonk and Mary Gansberg**

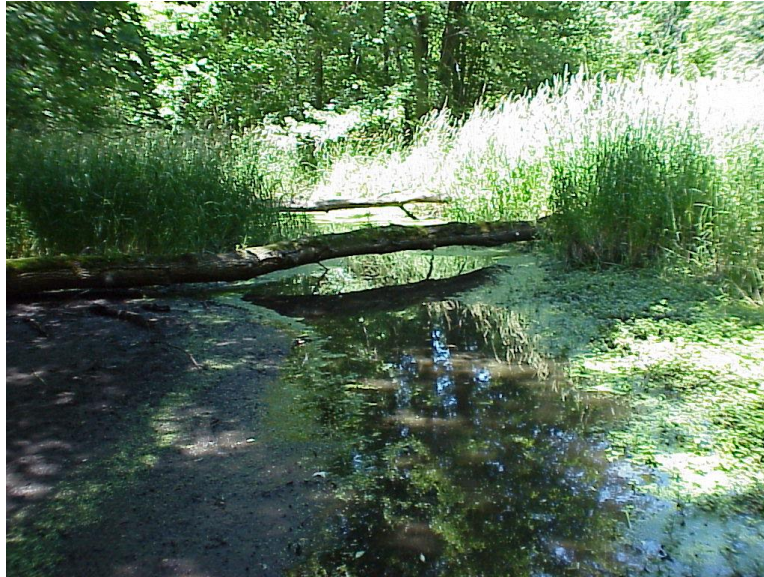
Figure 17. Looking upstream at Mud Creek above County Highway K. The bare soil, duckweed and low water was common throughout the surveyed section of river.
